REFRACTORY CHAMBER MATERIALS FOR $N_2O_4/AMINE$ PROPELLANTS

J. G. Compbell
THE MARQUARDT COMPANY
VAN NUYS, CALIFORNIA

TECHNICAL REPORT AFRPL-TR-73-31 May 1973

AIR FORCE ROCKET PROPULSION LABORATORY
DIRECTOR OF SCIENCE AND TECHNOLOGY
AIR FORCE SYSTEMS COMMAND
EDWARDS AIR FORCE BASE, CALIFORNIA 93523

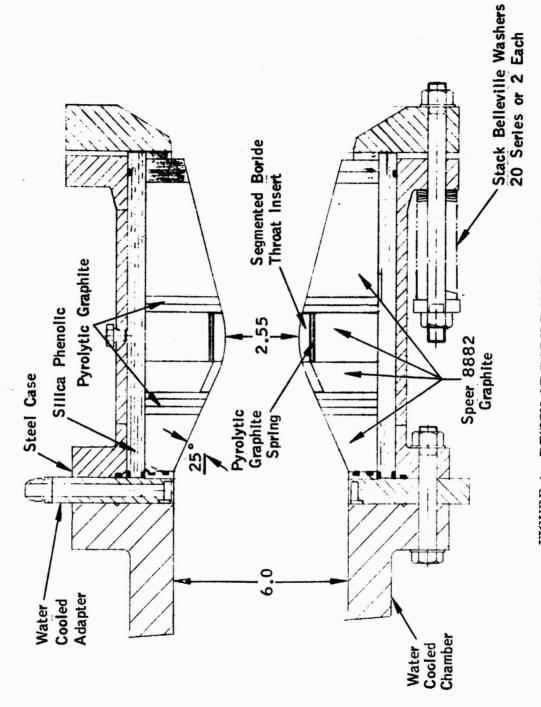
FIGURE 4. DESIGN OF BORIDE NOZZLE NO. 1

The No. 1 Boride Nozzle Assembly shown in Figure 4, was test fired at AFRPL using N₂O₄/N₂H₄ propellants, at a mixture ratio of 1.15. The C* efficiency was 78.5%. The nozzle failed and the firing was terminated after 47.6 seconds. The first significant drop in chamber pressure, from about 380 psig to 350 psig, occurred 12 seconds after ignition. The chamber pressure had risen slightly by about 10 psi just before the sudden drop in pressure at 12 seconds. The chamber pressure dropped gradually from 350 psig to about 338 psig at 30 seconds after ignition, at which time a sudden drop in chamber pressure to 315 psig occurred, followed by gradual decline to 285 psig at the time of shutdown.

Post test examination of the nozzle showed that all three segments of boride had be n ejected from the nozzle. Small fragments of boride shown in Figure 14 were picked up near the test site. The thickness or shape of most of the fragments was sufficiently clear to distinguish between the upstream insert and the throat segmented inserts. Photomicrographs of some of the throat fragments were taken, which provided identification of the material composition (either Material V or Material VIII (18, 10). The results of the visual and microstructural evaluation are summarized in Table III The amount of oxide on the Material VIII (18, 10) fragments was much greater than that on the Material V fragments from either the upstream ring or the throat segment.

- a. The upstream ring of Material V cracked into small pieces and was ejected immediately after ignition. It was expected that the upstream ring would suffer thermal stress cracking, based on approximate comparisons with the extensive stress analysis done on throat ring inserts and segmented throat inserts. However, it had been hoped that the upstream ring would remain in place. The crack propagation was evidently so severe that the upstream ring broke into fragments small enough to pass through the throat.
- b. The throat segment made of Material V cracked and was ejected from the nozzle immediately after ignition. The maximum thermal stress in the throat insert had been calculated to be 56,800 psi one second after ignition, assuming instantaneous chamber pressure of 400 psia. The

actual chamber pressure rise took about 0.4 second, but this reduction of the thermal stress environment was not sufficient to avoid thermal stress failure. The strength of Material V is only 48,000 psi, and it had been recognized that the design was marginal in strength.

The throat segment made of Material VIII (18, 10) was not ejected from c. the nozzle until 30 seconds after ignition. The sequence of events cannot be established with certainty, but the best explanation is that after ejection of the Material V throat segment, the Material VIII (18, 10) Segment was free to move transversely a distance of about 0.5-inch, which would allow gas flow around the insert and would produce bending moments in the axial and possibly radial directions. Evidently this condition prevailed until the insert reached a temperature at which its tensile strength was exceeded by the bending stresses. There is no strength data available for the borides above 3300°F, and the insert probably reached 4000°F or higher. The room temperature strength of Material VIII (18, 10) is anisotropic, being about the same as Material V in the pressing (axial) direction, but being significantly higher (75,000 psi) in the circumferential direction, perpendicular to the pressing direction. It was concluded that the strength of the Material VIII (18, 10) was sufficient to withstand the thermal stress just after ignition, whereas Material V failed.

A second boride nozzle, shown in Figure 15, was designed after post test evaluation of the first boride nozzle. Both 180°F throat segments were made of Material VIII (18, 10). The upstream boride ring was eliminated and replaced by pyrolytic graphite washers. The length of the throat inserts was reduced to approximately 0.60-inch in order to reduce axial stresses. The throat inserts were also made thicker (0.52-inch) than in boride nozzle No. 1, with an outside diameter of 3.60 inches instead of 3.30 inches. The design of the throat segments for boride nozzle No. 2 is shown in Figure 16. Pyrolytic graphite springs were used as in boride nozzle No. 1. Radial slots were milled on the face of the downstream pyrolytic graphite washer which retained the throat segments. The slots were designed to maintain pressures surrounding the throat segments which would be lower than the average pressure on the inside of the inserts. This should eliminate the possibility of ejecting the insert in case of cracking.

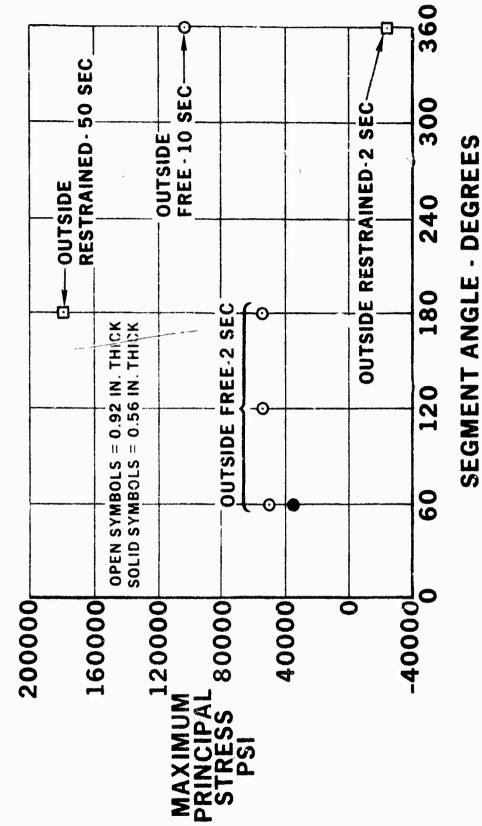
FIGURE 8. MAXIMUM STRESS FOR VARIOUS INSERT CONFIGURATIONS

Since the borides are brittle materials, maximum principal stress exceeding tensile strength was assumed to be the failure criterion. The effects of various types of inserts and external boundary conditions are shown in Figure 8. These results, for a throat insert thickness of 0.96-inch, should be representative of boundary condition effects for other thickness inserts. It is shown in Figure 9 that a continuous ring insert (360° segment) reaches a maximum principal stress early in the firing, and then experiences reduced stresses as the insert temperature approaches steady state. If the insert is split into two 180° segments, and is free to expand radially, the maximum principal stress is reached much earlier in the firing, and is only about half of the magnitude of stress reached in continuous ring inserts. The thermally expanded shape of such an insert is shown in Figure 10.

The effect of segment are angle is shown in Figure 8 for a condition of plane stress. It is shown that the first split in the insert is the most effective, with stresses of about 100,000 psi in a continuous 360° insert dropping to about 50,000 psi for a 130° segment. Additional reduction in are angles to 60° does not cause much greater reduction in stress. Therefore, the final stress analyses to select the best insert thickness were made for 180° throat segments.

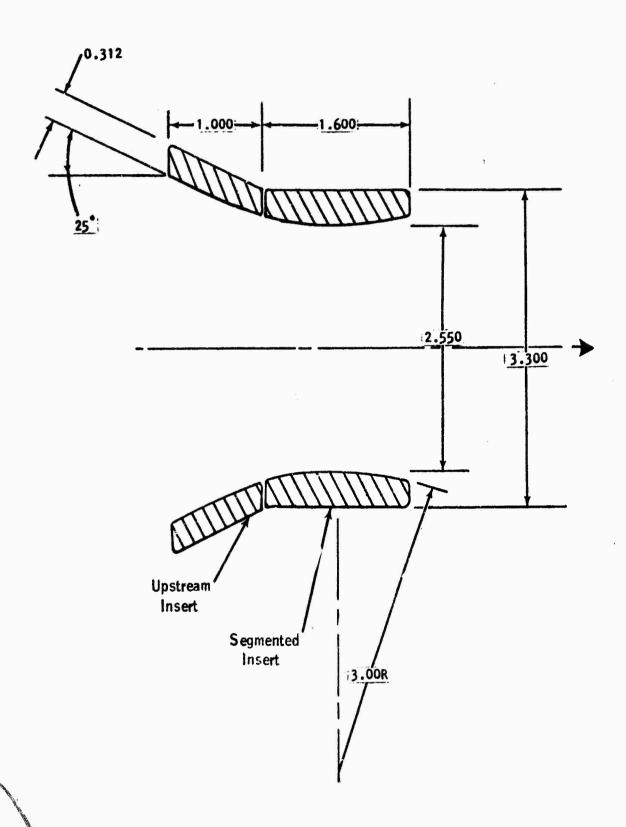
FIGURE 12. DESIGN OF INSERTS FOR BORIDE NOZZLE NO. 1

Detailed design of the boride inserts is shown in Figure 12. A pyrolytic graphite leaf spring was placed in the gap outside of the throat segments to keep the segments centered in the throat during ignition and firmly constrained during handling and vibration.

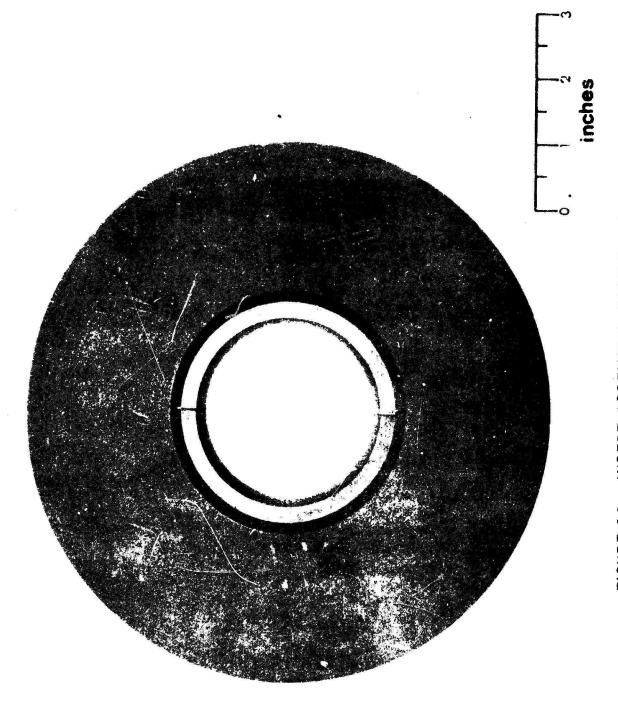
FIGURE 13. INSERT ASSEMBLY, BORIDE NOZZLE NO.1

The boride inserts were fabricated by Man Labs, Inc., Cambridge, Mass. The assembly of the two throat inserts and the pyrolytic graphite springs is shown in Figure 13.

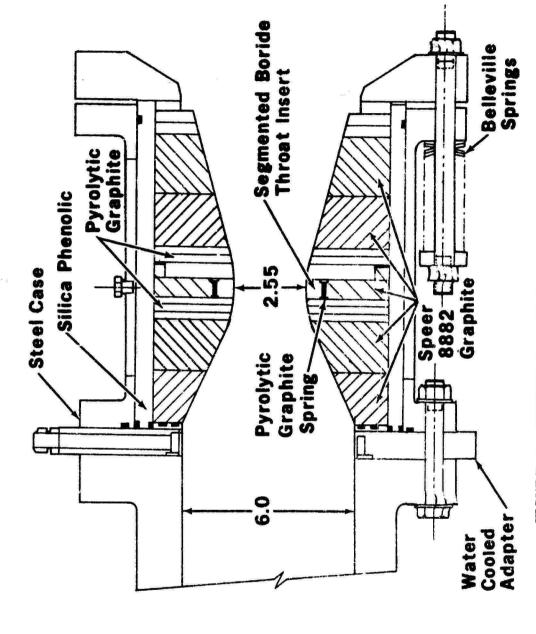
FIGURE 15. DESIGN OF BORIDE NOZZLE NO. 2

Boride Nozzle No. 2 was test fired successfully with excellent results. A first firing of 25 seconds was made with the propellant combination $N_2/O_4/N_2H_4$ at a mixture ratio of 0.94. The C* efficiency was 94.5%. The chamber pressure was 401 psig during the 25-second firing, after which the nozzle was removed from the stand, examined, and photographed. The nozzle entrance after the 25-second firing

is shown in Figure 18. There was no measurable throat crosion and the oxide layer on the boride segments seemed to be in the same condition as before the firing. It seemed probable that the pre-oxidized coating had adhered throughout the engine firing. There were no visible cracks in the boride segments.

The cracks in the boride segments were apparently caused by cracking and displacement of one of the pyrolytic graphite springs, which prevented full thermal expansion of the segments as they approached steady state temperature. This condition is described by the results of stress analysis of 180 degree segments, restrained on the outside surface, as shown in Figures 5 and 9. The fact that the PG springs were overstressed is also indicated by the delamination seen in one spring.

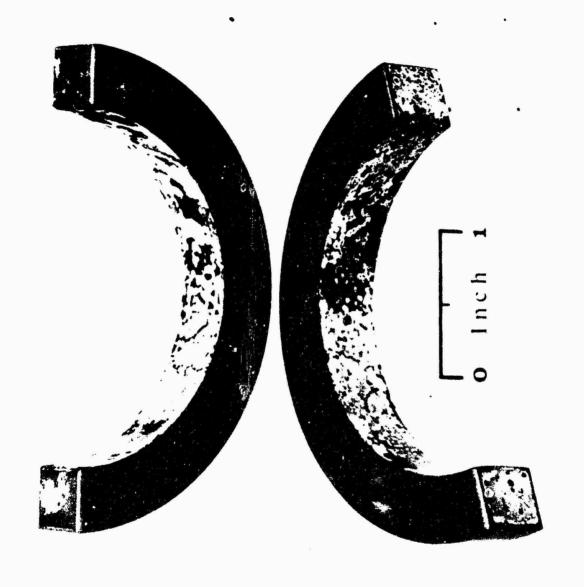
FIGURE 17. PREOXIDIZED THROAT SEGMENTS

The coating formed by preoxidation was not uniform in appearance, as shown in Figure 17. The coating was a mixture of glassy SiO2 and white ZrO2. A pyrolytic graphite ring of the size desired to fabricate the pyrolytic graphite springs could not be procured due to lack of funds at this point of the program. Therefore, an available pyrolytic graphite ring was used to make the four springs. After cutting the springs, their stiffness was found to be much greater than desired, but assembly of the Segmented Nozzle No. 2 with these springs was possible.

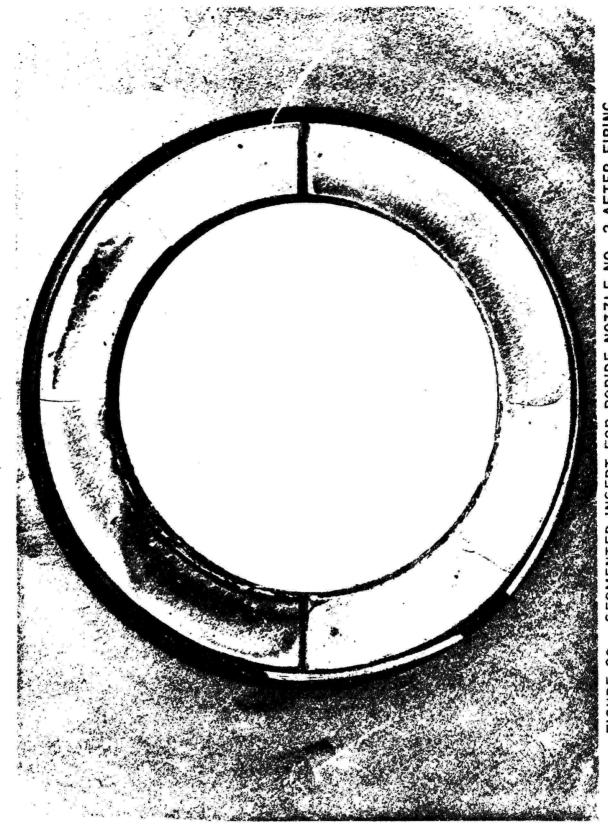
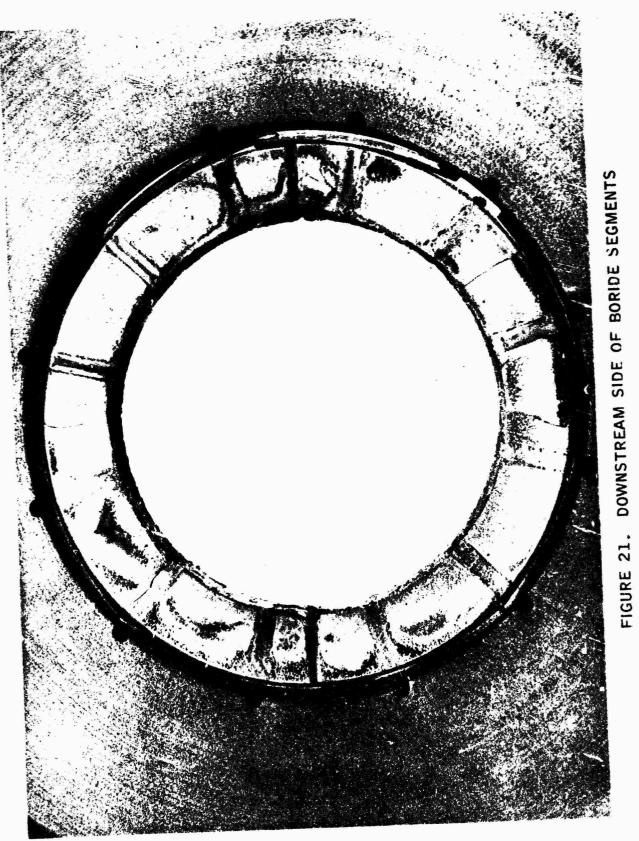
SEGMENTED INSERT FOR BORIDE NOZZLE NO. 2 AFTER FIRING FIGURE 20.

The first test firing had been terminated at 25 seconds because of a mechanical failure of the injector pintle, causing a large drop in performance and chamber pressure. After replacement of the pintle, a second firing was made for 53 seconds at a mixture ratio of 0.93. The C* efficiency was 84.5%. The firing was terminated because of overheating of the injector, causing an excessive rise of fuel manifold pressure. A very slight drop in chamber pressure was noted during the 53-second firing, from 360 psig to 357 psig. The nozzle throat is shown in Figure 19. There was evidence of some slight erosion, and several cracks in the boride segments. The boride segments and pyrolytic graphite springs are shown after disassembly of the nozzle in Figure 20.

The effects of the bypass flow of gas around the boride segments and through the slots in the aft PG washer are shown by the oxidation streaks on the aft side of the boride segments, as shown in Figure 21. This bypass gas flow did not seem to cause any problem in the nozzle insert.

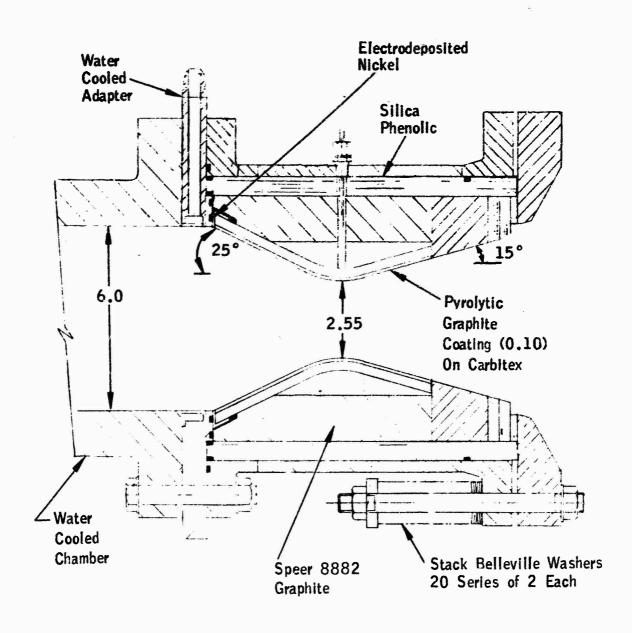
FIGURE 22. DESIGN OF PYROLYTIC GRAPHITE/CARBITEX/ NOZZLE NO. 1

A pyrolytic graphite coated Carbitex 713 nozzle was fabricated with the design shown in Figure 22. The structural design and durability of a similar nozzle had previously been established during test firings with fluorinated propellants. The interest in a PG/Carbitex nozzle for the current program, which required oxidation-resistant rocket nozzles, was due to the results of test firings of pyrolytic graphite coated nozzle inserts in N_2O_4/N_2H_4 reported in Reference 3. The low erosion rates reported therein were difficult to explain in light of the available data on oxidation rates of pyrolytic graphite. Therefore, a pyrolytic graphite coated nozzle was included in the program with the primary objective of determining chemical erosion rates in a large nozzle with N_2O_4/N_2H_4 propellants. Such propellants, at a mixture ratio of 1.2, would produce a water vapor mole fraction of about .45. The predicted throat erosion rate at a wall temperature of 4000° F was about 0.3 mil/sec, which would be excessive for the contract objectives.

The nozzle assembly (Figure 22) was designed to provide a free-standing PG/Carbitex nozzle attached and sealed to the water cooled adapter by spring loading against Viton O-rings in the adapter. This required that the front edge of the Carbitex be smooth and free from delaminations or flaws, which would provide leak paths around the O-rings. When the final cut was made on the edge of the Carbitex chamber after application of the PG coating, deep grooved delaminations were found in the Carbitex. Electrodeposited nickel was then deposited on the front end of the chamber and machined to form a smooth, flat forward face of nickel to bear against the O-rings. The nickel flange and entrance of the nozzle is shown in Figure 23.

There were a number of circumferential surface flaws in the entrance region of the Carbitex, which caused clusters of pyrolytic graphite nodule growth. The throat region was quite smooth, without any flaws in the Carbitex or nodule clusters in the pyrolytic graphite coating.

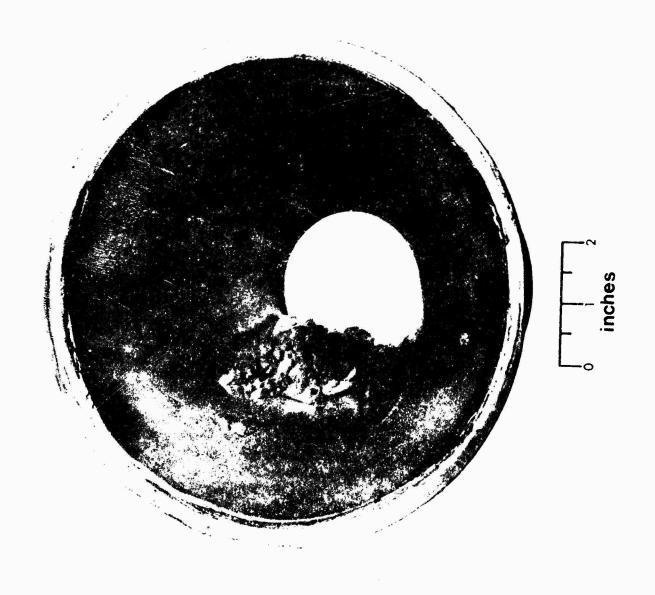
FIGURE 31. ZrC/PG COATED CARBITEX

Dendritic growths occurred in both nozzles, but the coating microstructure, thickness and adhesion to the Carbitex was excellent in areas not affected by the growths.

The coating produced by the second furnace run is shown in Figure 31 . A third furnace run made with an ATJ graphite nozzle produced similar growths. Analysis of the flow rates and nozzle geometry led to the conclusion that the growths were caused by flow separation due to rapid area expansion and were unrelated to slight surface flaws on the Carbitex. It was expected that the problem of dendritic growth could be solved without much difficulty by proper design of a plug for control of flow expansion in the exit nozzle. However, this portion of the contract effort was discontinued after the third run because of program redirection.

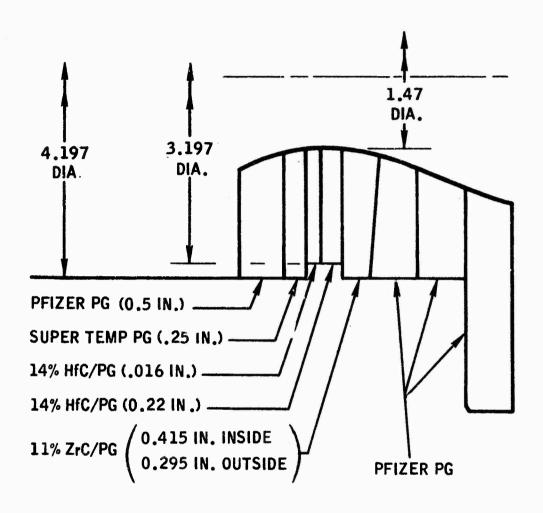
PYROLYTIC GRAPHITE WASHER NOZZLE AFTER TEST FIGURE 36.

The zirconium pyrocarbide washer had eroded in a manner very similar to the pyrolytic graphite washers. There was no evidence of dry or molten oxide having formed. It seems likely that surface spalling of the washer was so rapid that a significant oxide layer could not form.

- (a) Erosion of the nozzles was primarily mechanical. The reason for the severe mechanical spalling is not known.
- (b) There was some evidence that molten HfO_2 was formed on the HfC/PG washers and adhered rather well in recirculation zones. Failure of the HfC/PG washers due to delaminations was more severe than that of the ZrC/PG washer. This was probably due to the presence of larger residual stresses in the flat HfC/PG deposited on rigid mandrels, as compared to the bowed ZrC/PG plate.
- (c' The throat erosion of the pyrocarbide nozzle was about the same as erosion of the pyrolytic graphite washer nozzle.
- (d) Deposition rate increased with increasing furnace temperature as shown in Figure 38.
- (e) Wt. percent metal decreased with increasing furnace temperature, as shown in Figure 39.
